## Helpful Information for You and Your Pool

### Algae and Coatings

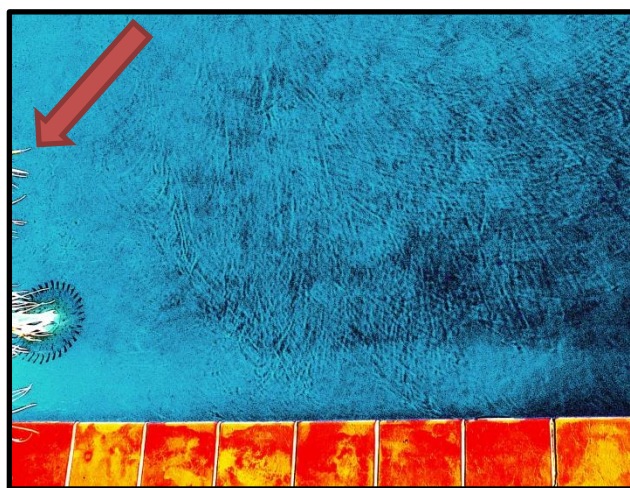
Here we can see “stains” moving away from the creepy crawler towards the right-hand corner where the surface is quite rough. The original pool surface area around the creepy crawler is quite smooth and thus clean as the coating is smooth also and follows the profile.

There is over-hanging vegetation just visible on the far left as well. (see arrow)

So, in this case the overhanging vegetation has led to matter falling into the pool, rotting and in areas where the original concrete surface is rough, with hills and valleys, algae forming in the bottom of the valleys, highlighting them. Yet it looks like the coating is faulty.

Treatment is quite straightforward, remove all overhanging or nearby vegetation, including palm trees

and resultant seeds and nuts. Then use a good algaecide (from pool shop), some brooming and vacuuming to remove residues.
