## Helpful Information for You and Your Pool

## Rust stains and pool resurfacing

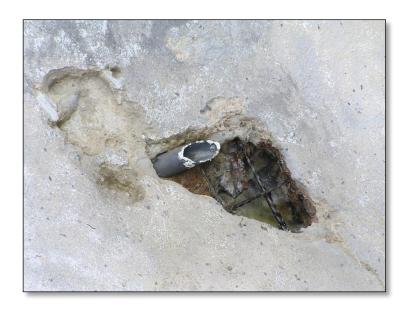
What you may see once you start digging into the rust spot. On closer inspection it can be seen that the rust is all around the steel and the concrete needs to be dug out completely and rusty steel exposed on ALL sides. This is vital for a successful result. The pic on right still needs a LOT more digging out

It's **vital to dig all concrete away from rusted steel and expose** it. Then wire brush all loose rust off. Once back to sound steel, apply an oil based anti-corrosive primer or a Kelate (rust converter). These are available from all the good paint shops.

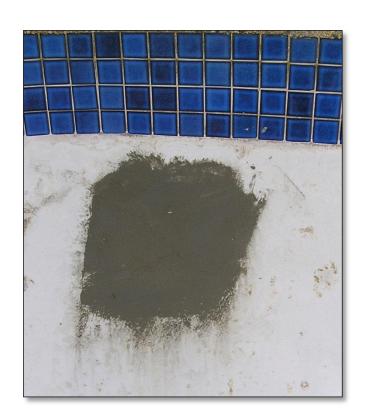
The finished surface which now blends in with nearby areas, is ready for coating with a hi performance coating.

Then refill voids with a sand cement mix. It may require 2 or 3+ applications 20 – 30 mm thick, to build back to original surface. To prevent shrinkage use a 3:1 washed sand to cement mix

(or a propriety mix) and cure correctly by keeping moist for several days in hot weather. You can smooth off the final surface to match adjoining areas.
