Helpful Information for You and Your Pool

# **Assessing Pools for Ground Water Issues**

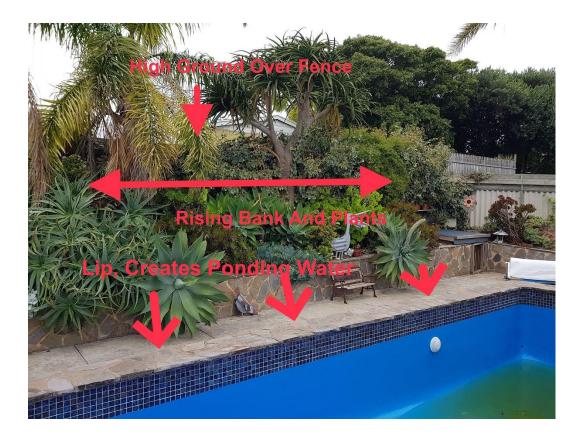
Image 2 Here is a pool with rising ground along one side (rises higher on neighbour's land) and combined with the rising bank and garden, is a great trap for rainwater and resultant seepage. (Into or under pool)

- Is the pool on a hillside, or is there a nearby bank or hillside, that allows water to run off or flow towards, under or around the pool and its immediate surroundings? (See image 2, below)
- Is the pool near the sea, marina, or river or at the bottom of a valley?
- Does the roof or rain run off flow away from the pool area? If not be aware.
- Are the pavers or coping tiles buckled, with gaps between them or lose?
- Is the pathway or coping tiles, pavers that surround the pool showing any signs of white efflorescence? (Also look at the tile line above the water for the same white efflorescence)
- Are the coping tiles or pavers dark in colour?

If you see any of the above factors then it's highly indicative of water being in, around or under the pool and this may impact on the success of the coating, now or many years later on.

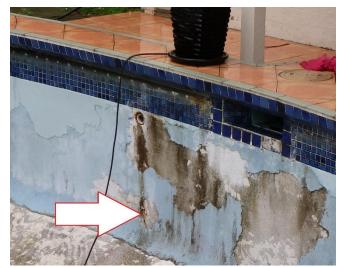
Figure 6 Hydrostatic blisters in painted surface, due to water (leakage, building up) behind pool shell.

- Any blisters in the existing pool coating will indicate moisture passing through the concrete shell into the pool (hydrostatic pressure). Note: A well-worn, thin pool coating may not show any effects as the water and vapour can pass readily through it. A worn coating is one key reason to recoat a pool. Also porous surfaces like Marblesheen and Pebblecrete usually show no issues with moisture issues.
