## Discussion about Marblesheen pools and upgrading with a Hi Performance Coating.

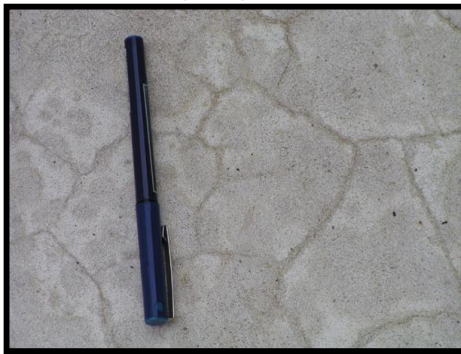
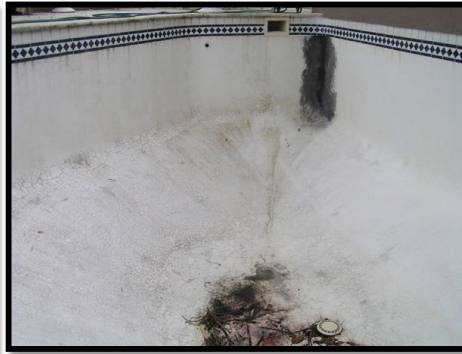
Over the years and depending on the quality of installation, pool water chemical balance and general wear and tear, it will slowly degrade. Usually, it ends up with random cracks, worn areas, black staining and maybe rust staining too. There can be large areas where the Marblesheen is soft and weak. (Pool acid literally eats into and weakens it) Some areas may be drummy (hollow underneath) or break away completely. There may be white calcium build ups as well.

Older pools often become hard to keep clean, with algae attacks common and particles of Marblesheen getting stuck in filters.

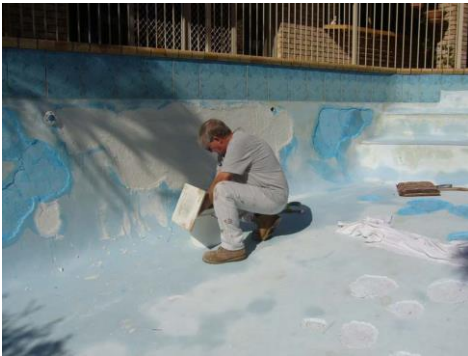
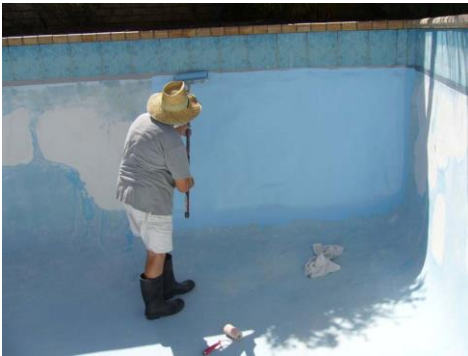
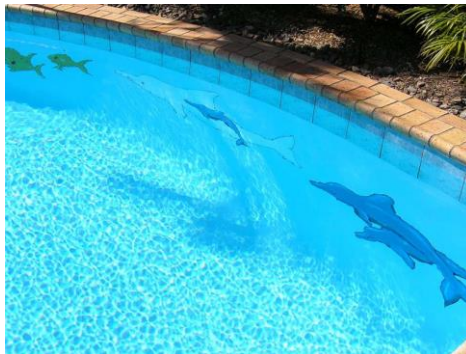
Undertaking repairs to Marblesheen, through to finished pool.

- Empty pool and look closely at surface.
- Check for drummy and soft / weak areas – remove & replace.
- Check for rust spots and if from below, deal with corrosion of pool structural steel work thoroughly.
- Algae roots need to be killed with algaecide
- Calcium residues need to be removed.
- Any missing, worn or rough areas should be filled before painting.
- A thorough clean to remove all fats, dirt and loose particles.
- Apply 1 – 2 coats of a sealer coat
- Apply 1 coat of a bodycoat. (optional)
- Apply 2 coats of Epoxy or Fluoropolymer) for a seamless, easy clean, long-lasting finish.
