Helpful Information for You and Your Pool

Pool Paint Defect Pictures

Some common issues with pool painting.

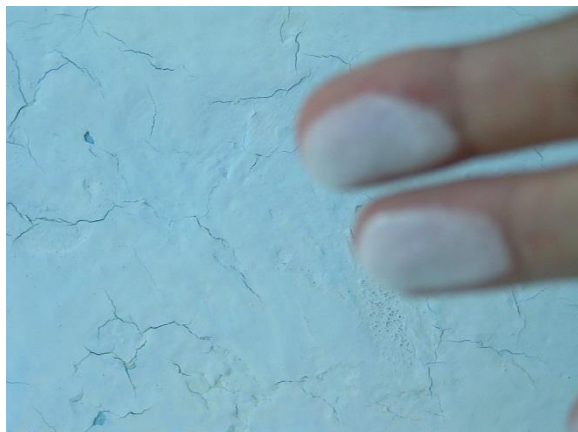
Fig 1: Paint can become chalky over time and leaves a film on your figures. This happens sooner with Chlorinated Rubber (1 – 2 yrs) and takes much longer with Epoxies. (5 -8 yrs) and for a MUCH longer life, Fluoropolymer, which does not chalk. It may also be quite often the result of insoluble residues in your (especially salt) pool. Need to check which.

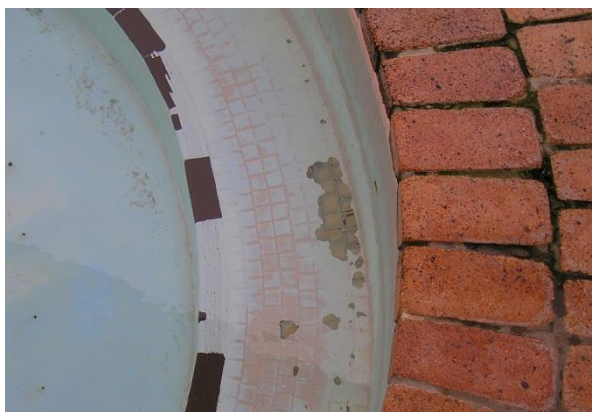
Fig2: (right) Painting of tiles is not recommended as it can lead to failure of the coating at the edges.

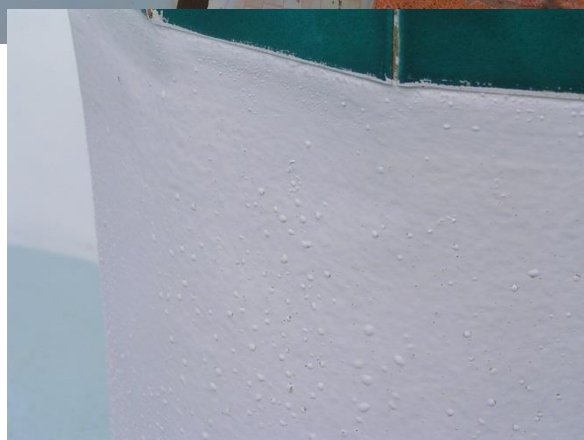
Fig 3: (below left) Blisters in a painted wall due to hydrostatic pressure of ground water rising up inside the concrete and being drawn to the surface, forming blisters.

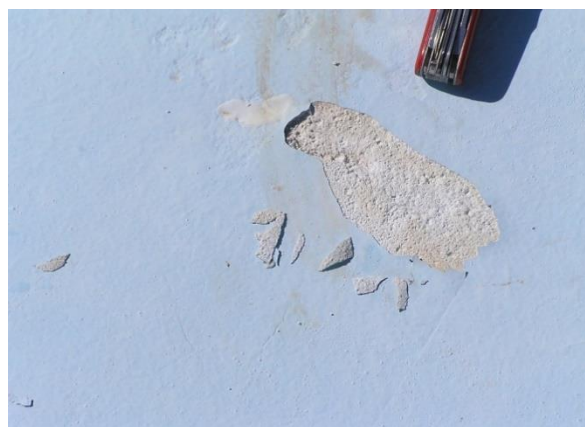
Fig 4: (above) The substrate failing internally and coming away, bringing the paint with it. Often due to hydrostatic pressure beneath and coming through the concrete shell.
