Helpful Information for You and Your Pool

Pools On Hill Sides or Close to Homes

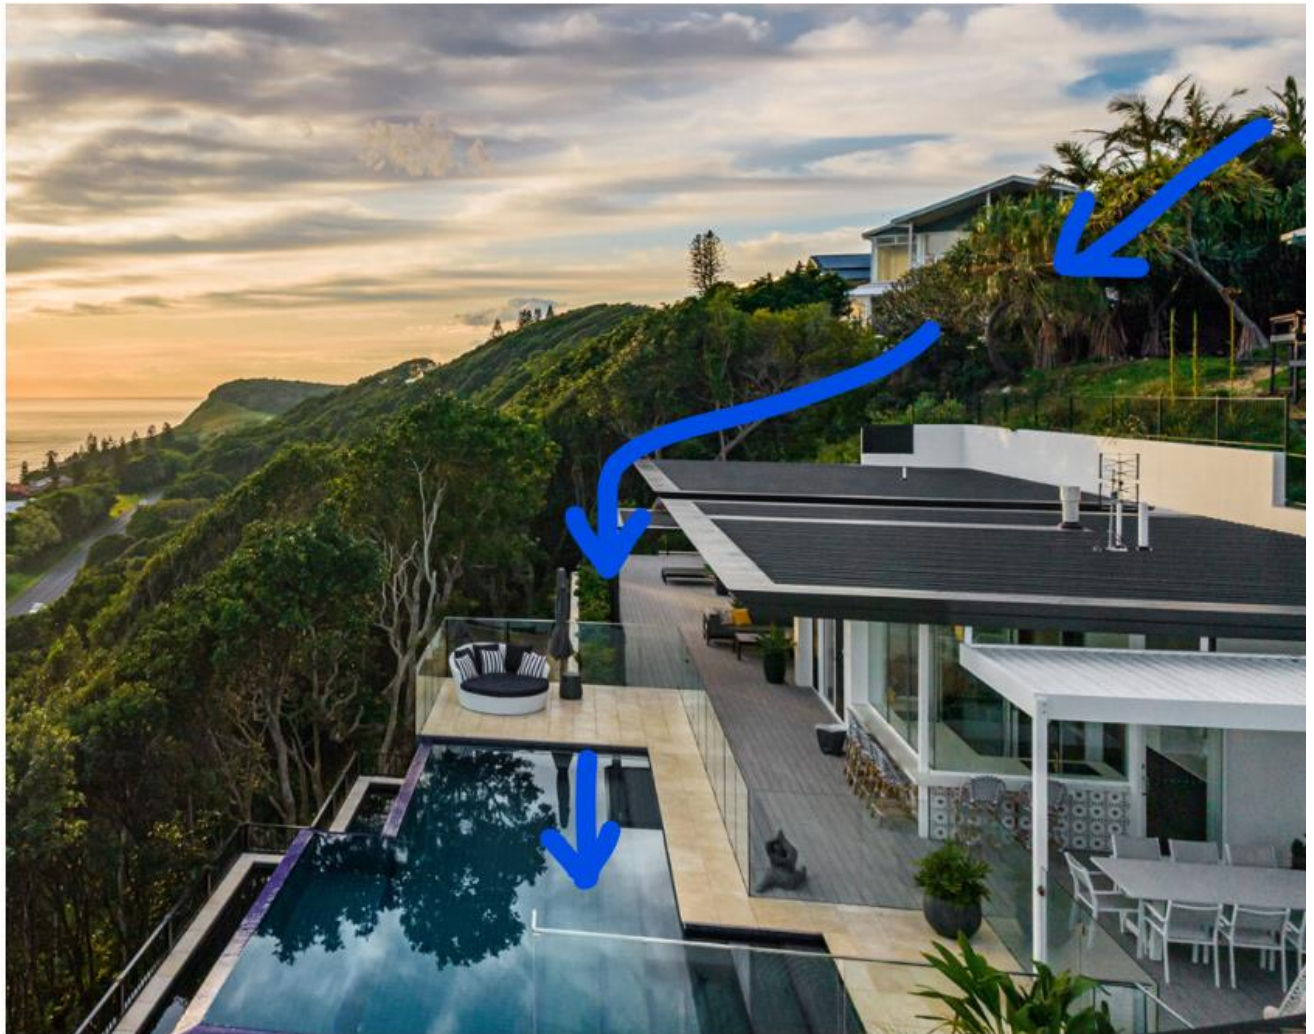
An example of a pool close to a home and potential cool air flowing down hill and into the pool.

Where there is any pool close to a house (like less than 20 metres), there is always the prospect of cool night air flowing OFF the roof and into the pool. It may end up at the deep end or if enough fill the whole pool, till morning sun heats it up. Such air has high humidity, and this can create an unexpected issue with partially cured paint. If the ground temperature is also low, less than 10C and even though you finished painting say at midday, the coating is not cured enough to resist the effects of this high humidity, low temperature air, overnight. In the morning you may find the surface partly white (Blushed) because of the effects of the overnight conditions. It may affect all the pool or some parts like the deep end only. Even if no effect, when the pool water is added a week or so later, it may turn white then, as the coating curing mechanism was interrupted by this situation, and it then is affected by full immersion in pool water.

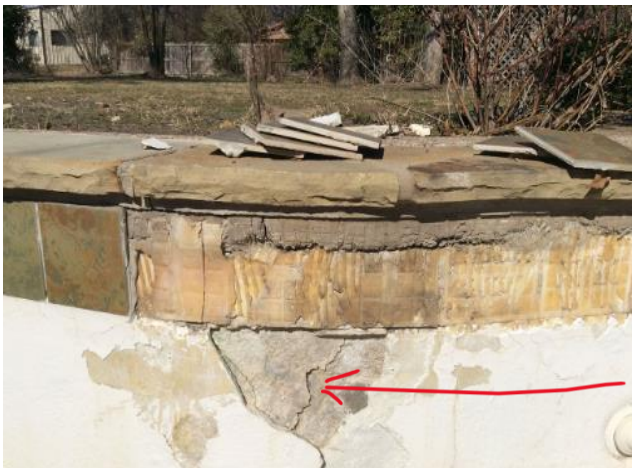
Here's a good example of all that is NOT good!

Structural crack in pool

Hopefully when you come to see the pool after it's been in the location for 20 years plus, it's still in a stable state. And thus, you can assume all is good. However, do look around for cracks, uneven pathways, subsiding banks and similar. Whilst you are not an "engineer" you should seek to be sure there are no obvious issues or indications of pending issues, for the sake of your reputation. If in doubt, ask the owner to get a professional engineer to investigate. And lastly tag your quote – contract that you are not an engineer and have no liability for any structural defects, seen or unseen.
